UNDERWATER BRIDGE INSPECTION REPORT

STRUCTURE NO. 5853

THE SOUTH BRANCH OF THE BUFFALO RIVER

MINNESOTA DEPARTMENT OF TRANSPORTATION
UNDERWATER BRIDGE INSPECTION

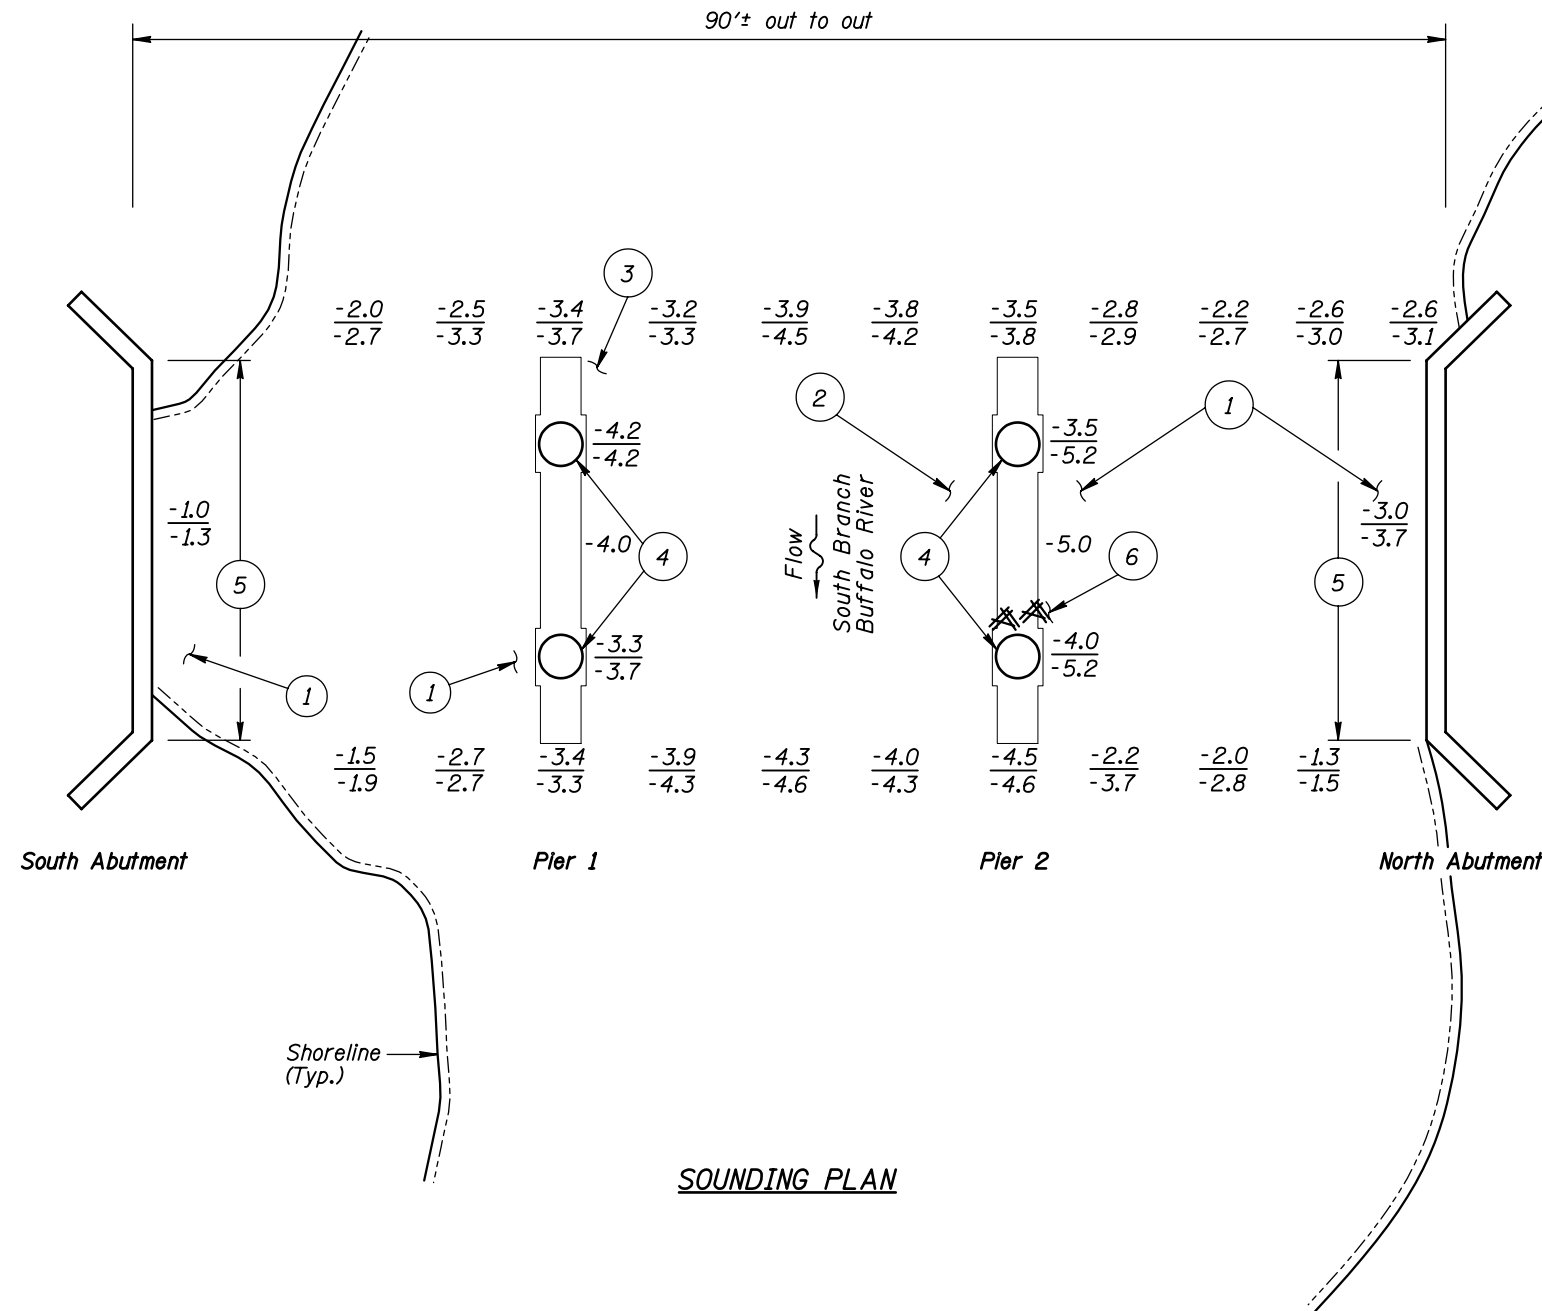
Date: OCT. 2002
Scale: NTS
Figure No.: I

- 1 The channel bottom consisted of silt and cobbles, up to 6 inches in diameter, with a maximum probe rod penetration of 1 foot.
- 2 The channel bottom consisted of silt and riprap, up to 12 inches in diameter, with a maximum probe rod penetration of 2 inches.
- 3 The channel bottom consisted of soft silt with a maximum probe rod penetration of 2 feet.
- 4 The concrete columns of the piers were in good and sound condition with no structurally significant defects observed.
- 5 The concrete of the abutments exhibited minor vertical and diagonal cracks at random locations, ranging in width from hairline to 1/8 inch.
- 6 A light accumulation of branchy timber debris was observed at the upstream side of the downstream column at Pier 2.

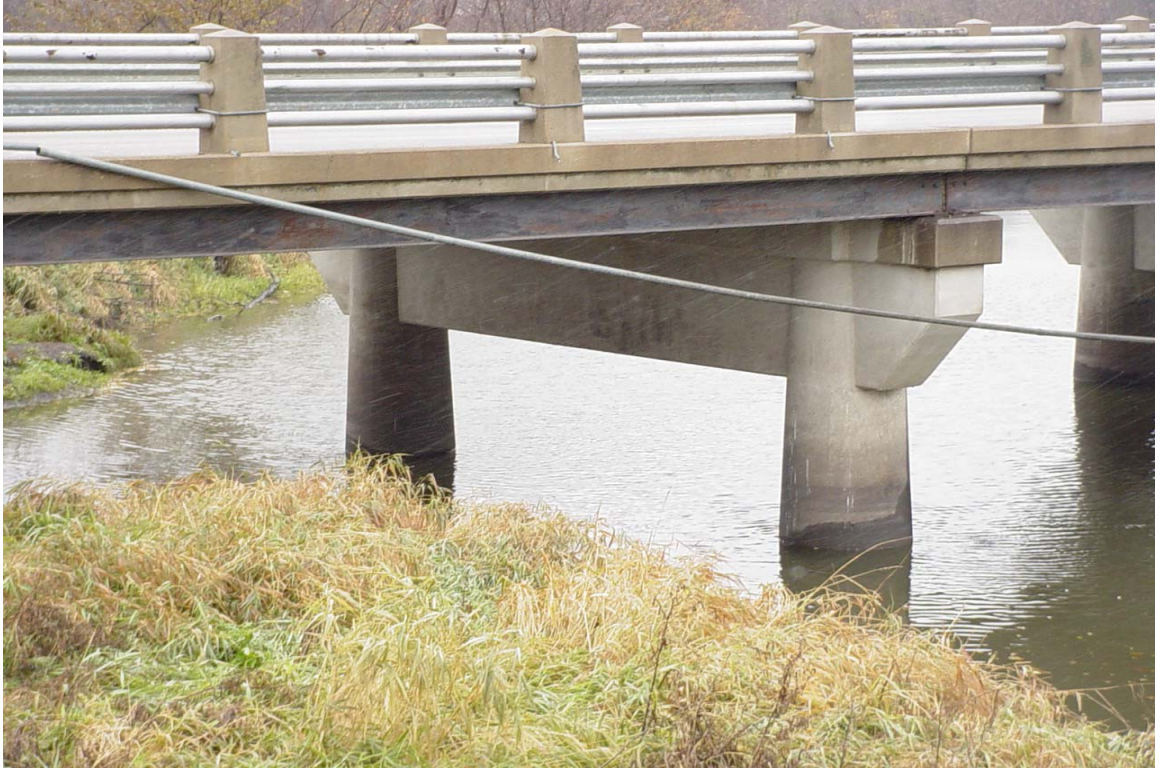
Photograph 1. View of Pier 1, Looking Northwest.

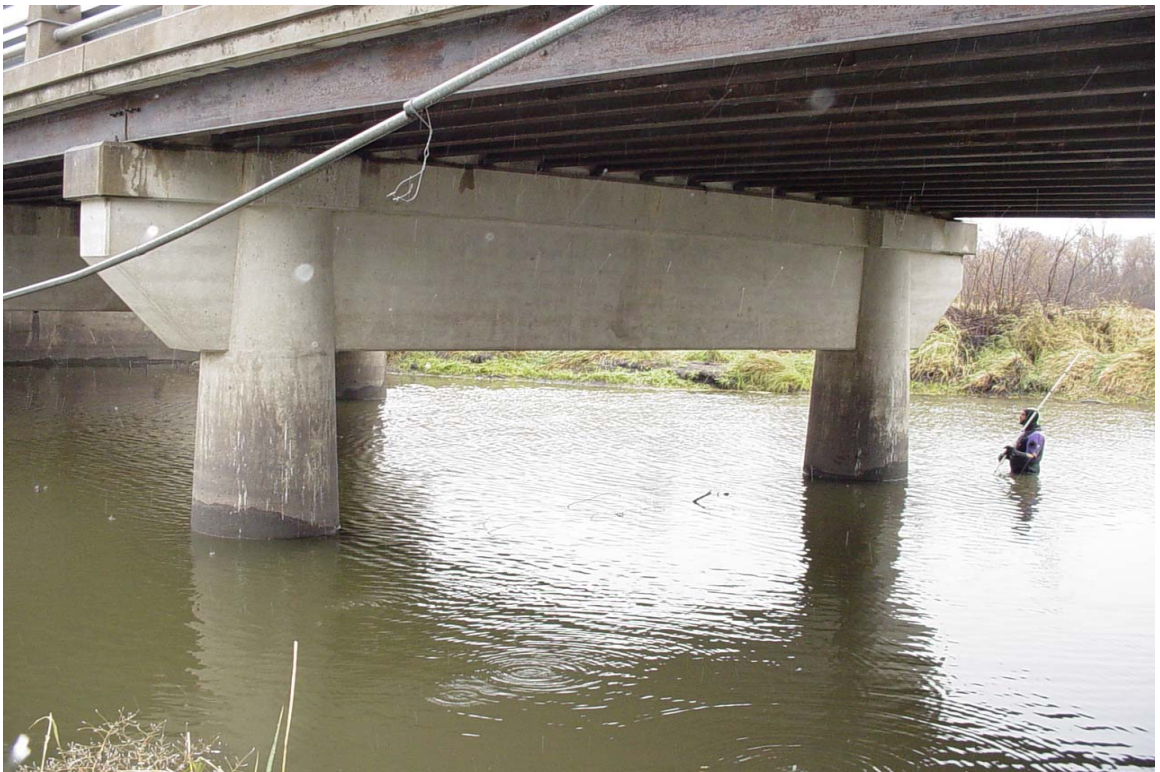
- (A) The concrete piers and abutments were in good condition. Both abutments displayed minor vertical and diagonal cracks at random locations, ranging in width from hairline to 1/8 inch.
- (B) A light accumulation of branchy timber debris was observed at the upstream side of the downstream column at Pier 2.

Photograph 2. View of Pier 2, Looking Southwest.

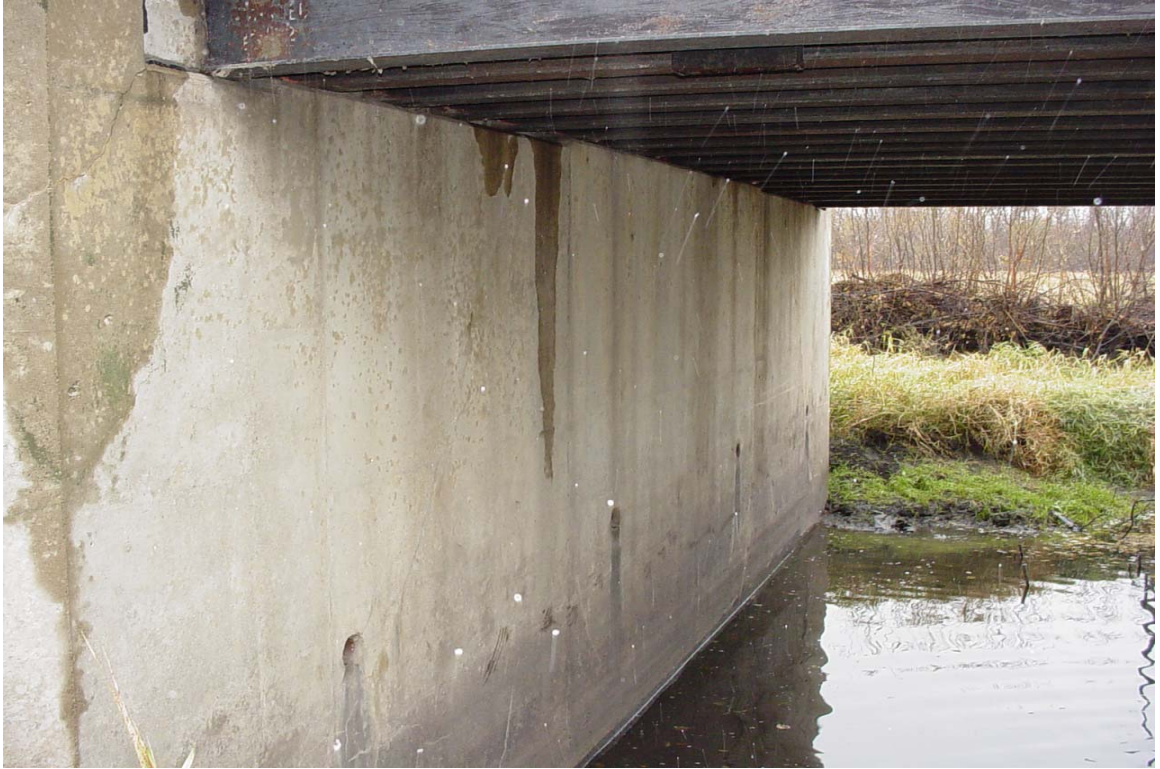
Photograph 3. View of South Abutment, Looking Southwest.

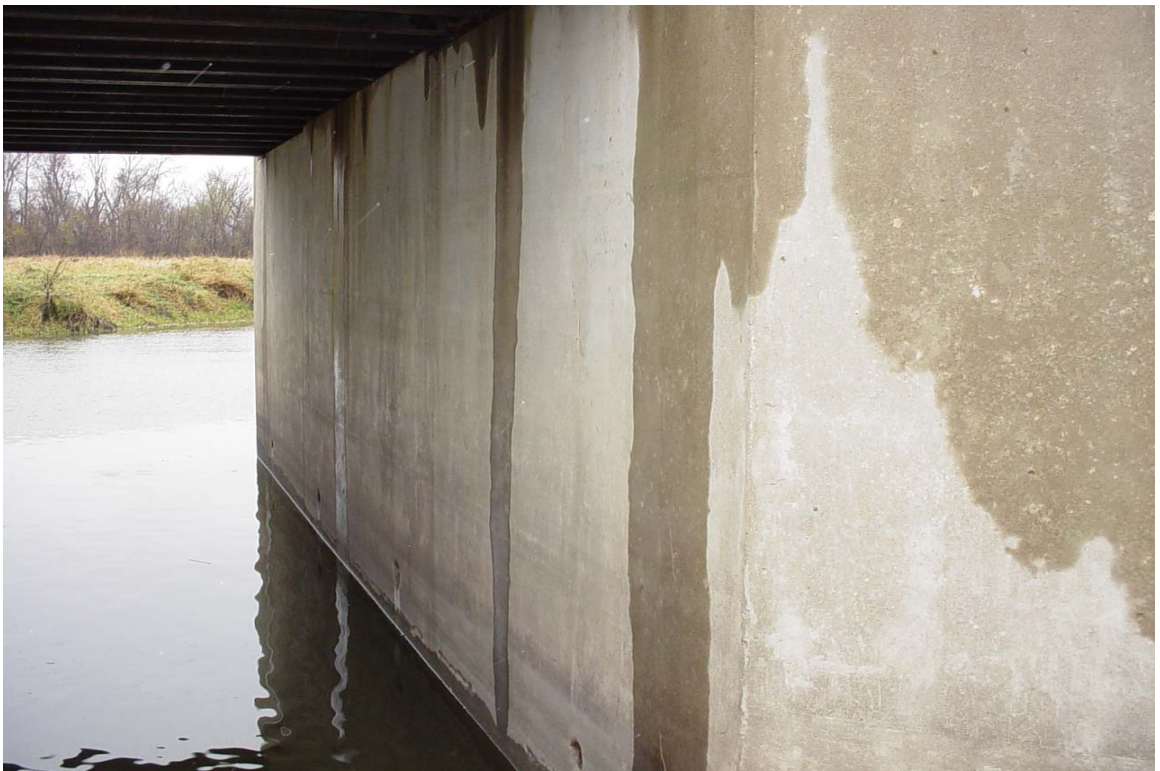
Photograph 4. View of North Abutment, Looking West.
